DFW Premier Home Inspections

Property Inspection Report

1234 Home Inspection way
Inspection prepared for: Sample Report
Real Estate Agent: Support - Home Inspector Pro

Date of Inspection: 5/20/2019 Time: 08:00
Age of Home: 1980 Size: 2265
Weather: overcast 45 degrees

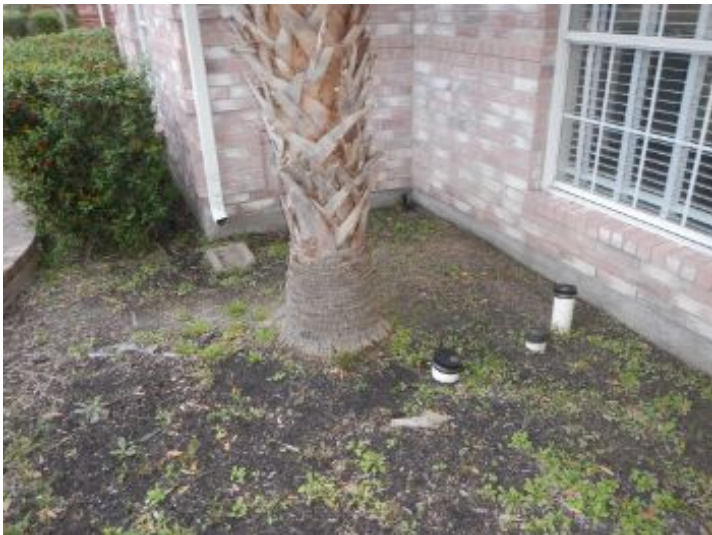
Possible drainage issue in front flower bed.

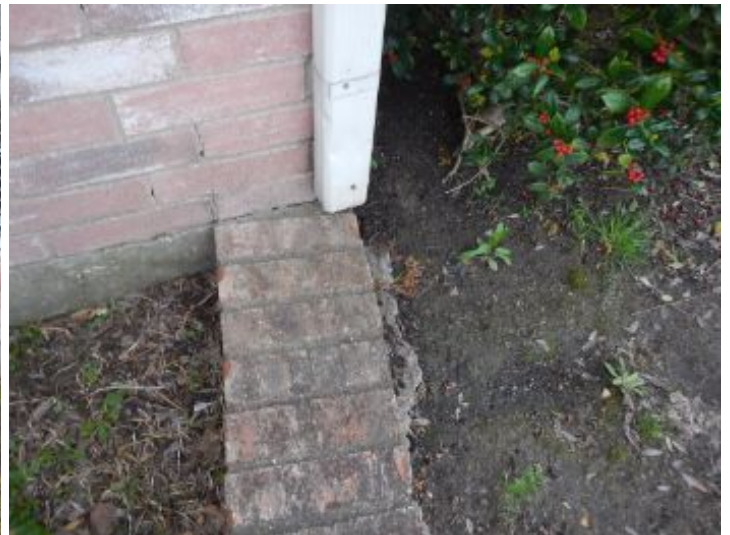
• The gutter system was partially blocked with debris and one or more downspouts or splash blocks were in need of repair. One of the downspouts was missing a diverter that should be installed

Missing gutter downspout diverter

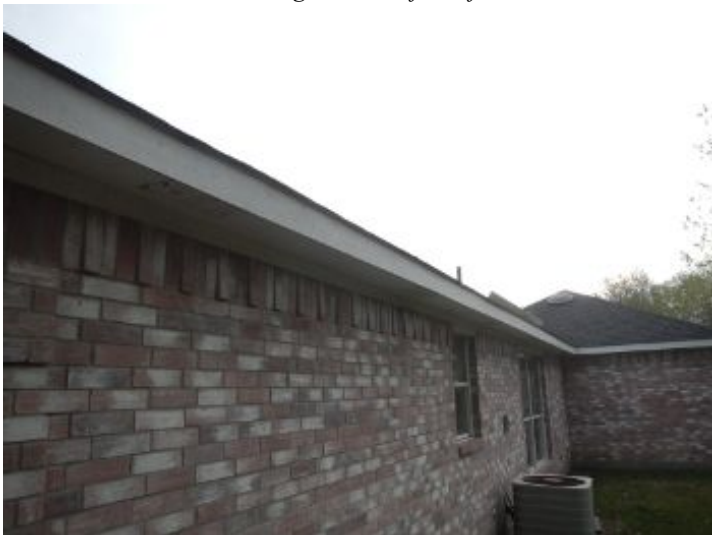
• Several areas around perimeter of home are missing gutters. These should be installed to help shed water away from foundation of home

Missing gutters in several areas

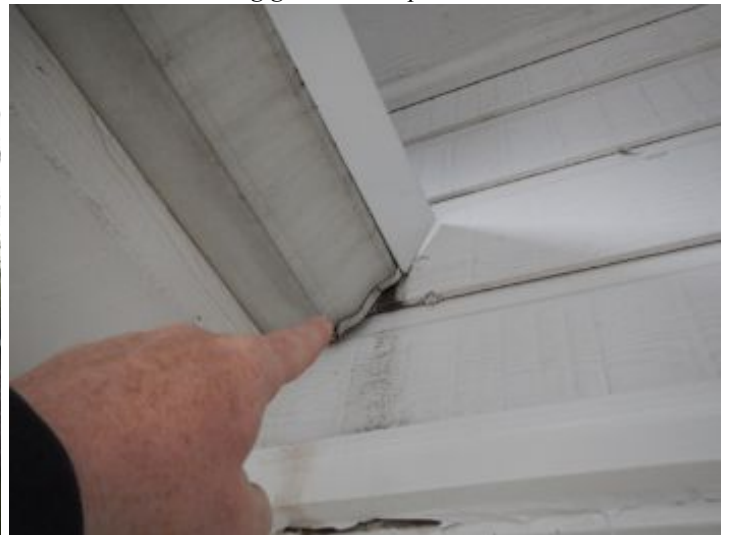
• Gutter next to back door of home appears to be leaking onto top of door. This should be evaluated and repaired to divert water away from door

Gutter appears to be leaking above back door to home

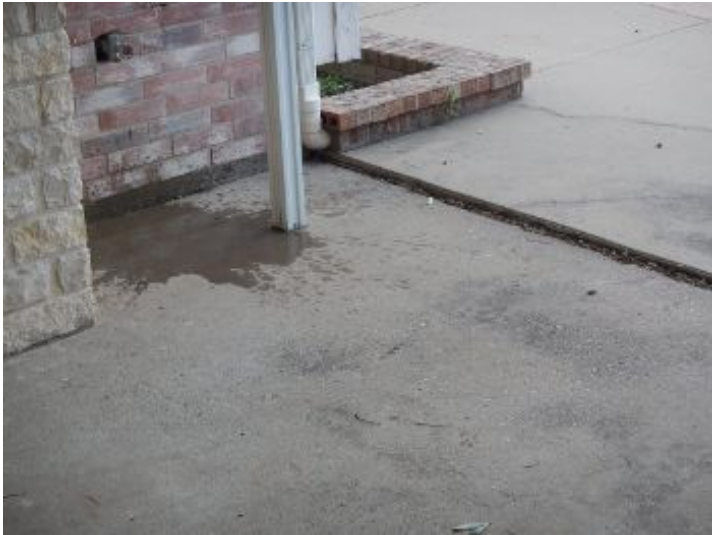
• Possible drainage issue on back porch due to raised concrete and pool deck appears to drain to home and not away from home. This should be evaluated and possibly repaired

Possible drainage issue due to heaved concrete

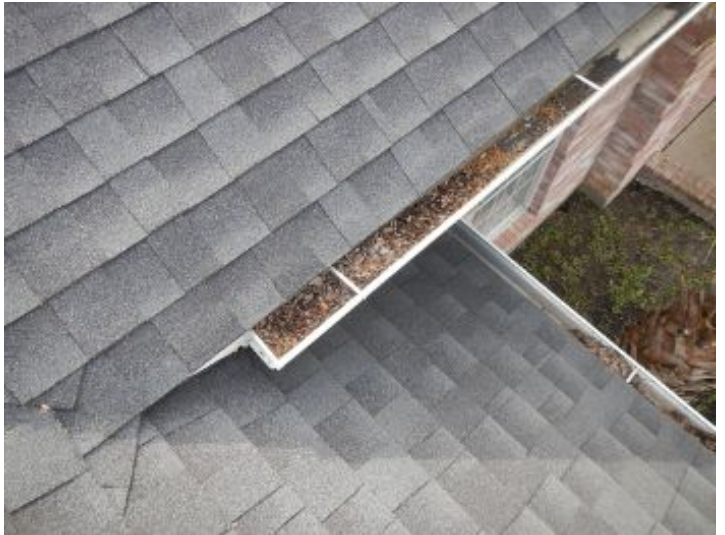
Several gutters are full of debris

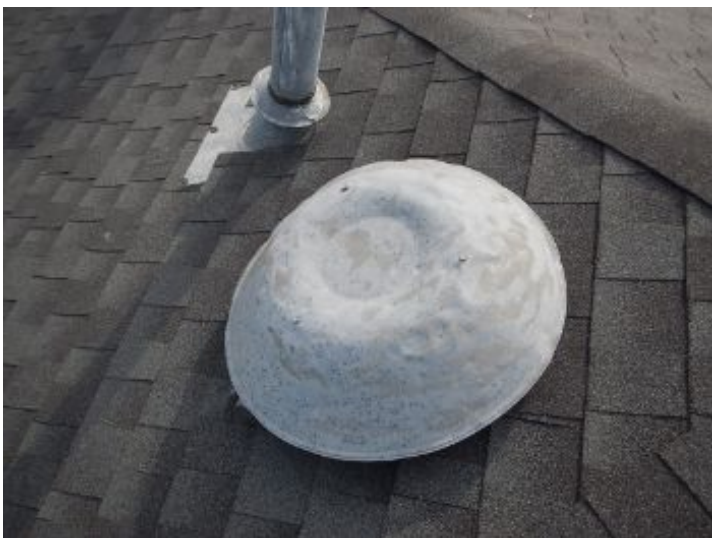
• Cosmetic damage to roof vents. If this is a concern to you then I would have them replaced

Cosmetic damage to roof vents on home

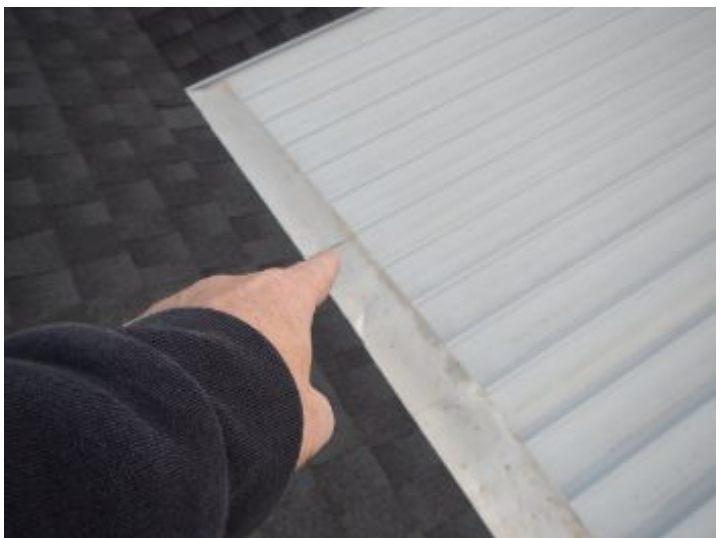
Flashing over patio cover should be sealed

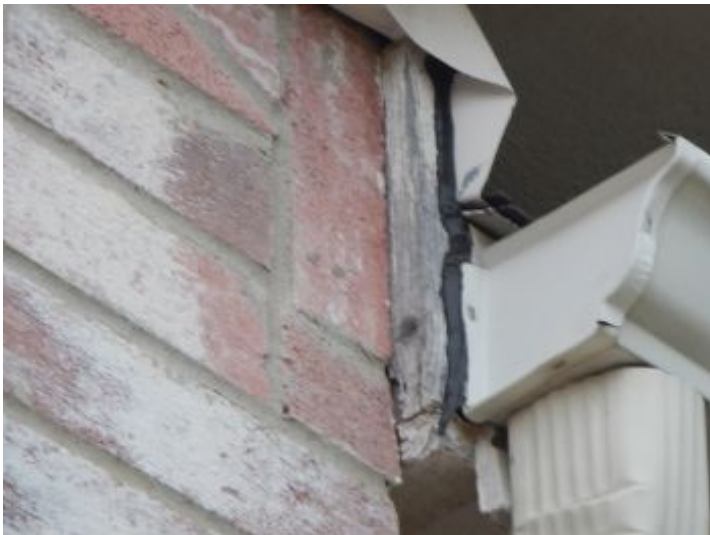
- **Several areas of the fascia of the home have areas of wood rot that need to be repaired and properly sealed**

Wood rot on several fascia boards of home

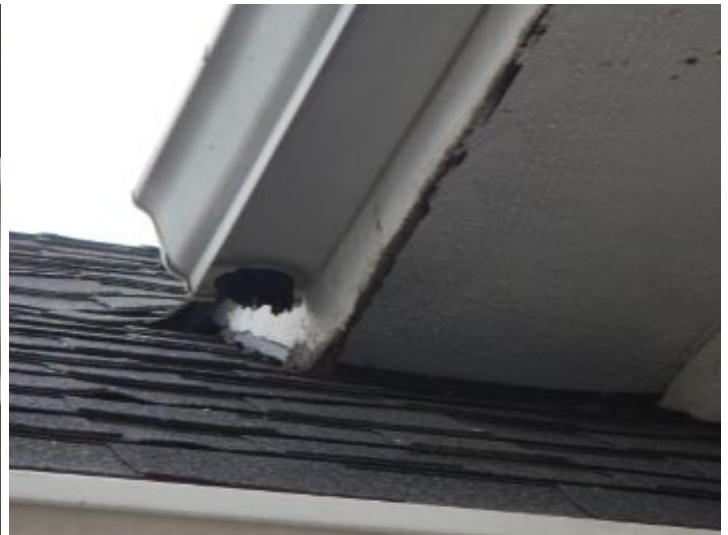
Wood rotten fascia boards needs repair

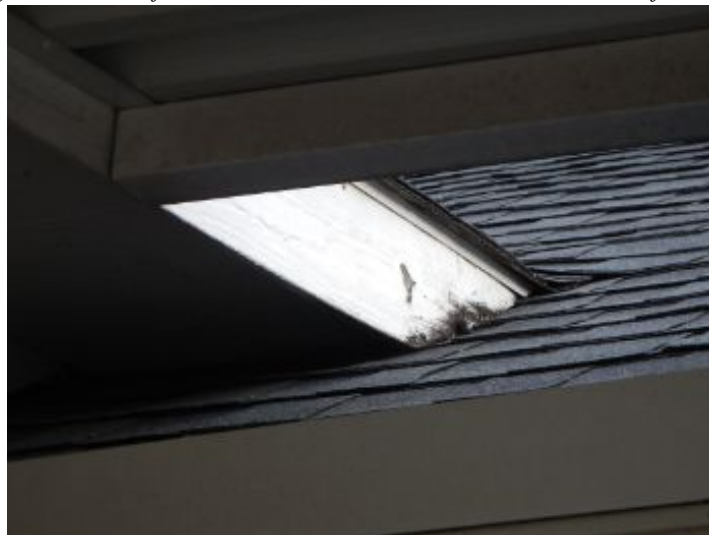
Wood rot on fascia over back porch

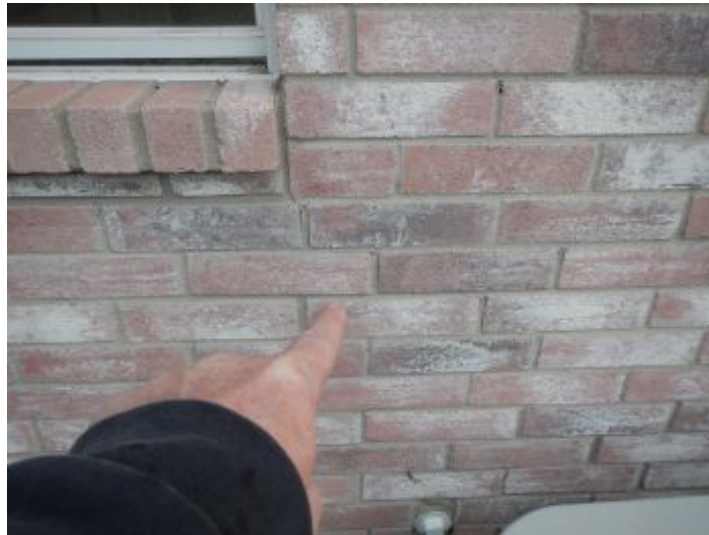
- Earth to wood contact was observed on the exterior siding and should be a minimum of {6"} clearance from the ground
- There are several areas of step cracking on exterior of home. These appear to be minor at time of inspection but should be monitored in the future for possible movement in the home

Small step cracks in brick on both sides of home

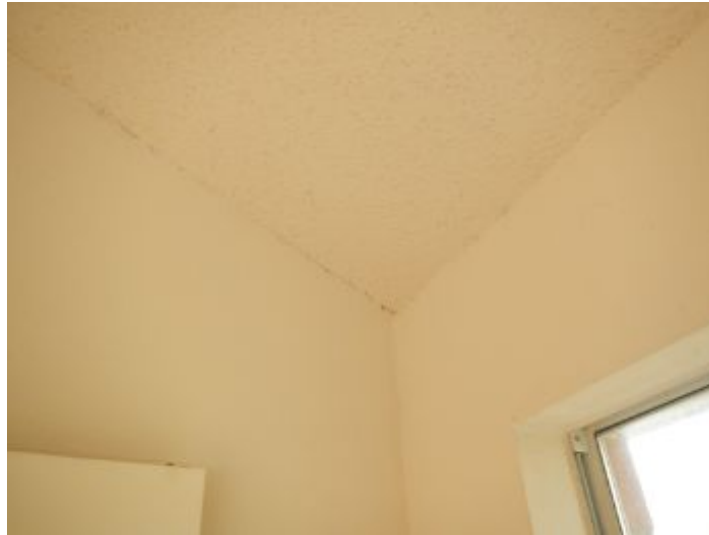
- Ceiling stress and/or joint cracks were observed. They appeared to be cosmetic at time of inspection.

Several cracks in ceiling of home appear cosmetic at time of inspection

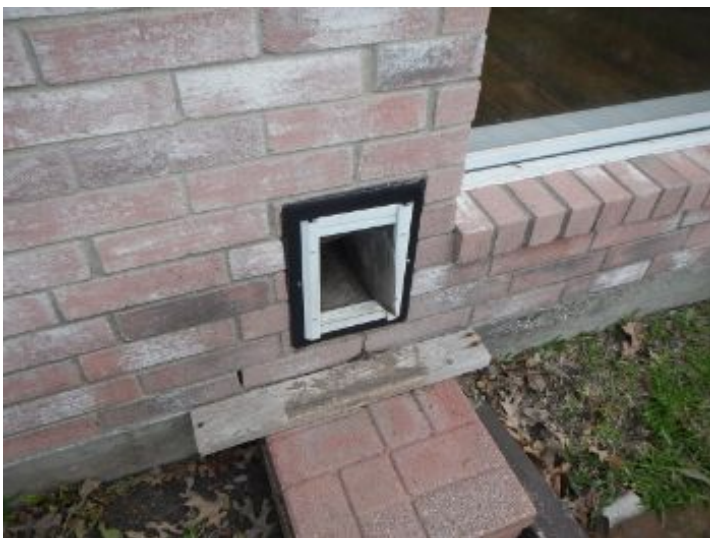
Pet door is compromised and needs repair

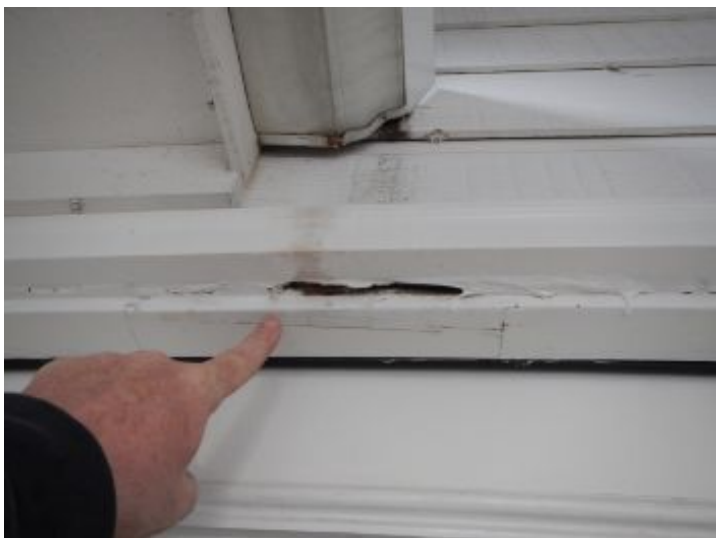
Trim around back door is rotten and needs repair

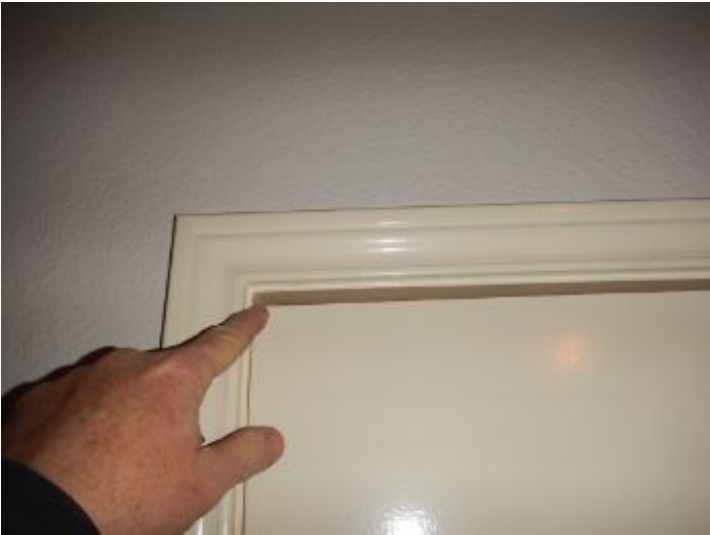
Back door is out of align

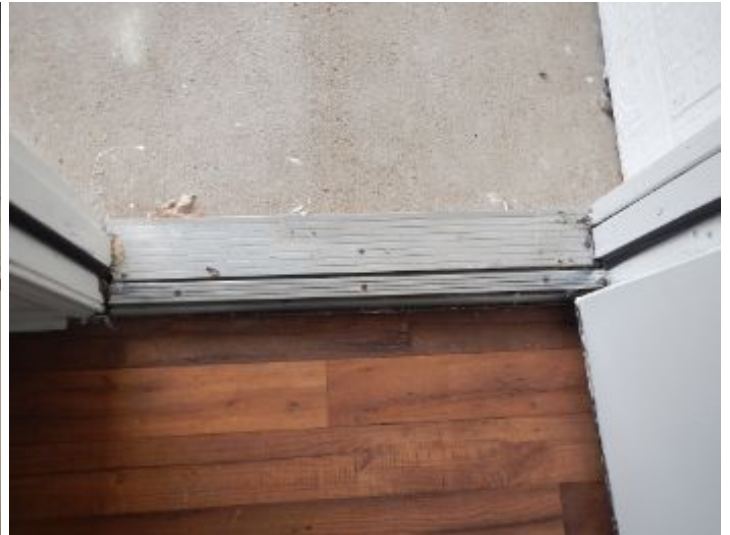
Back door to patio has a loose threshold

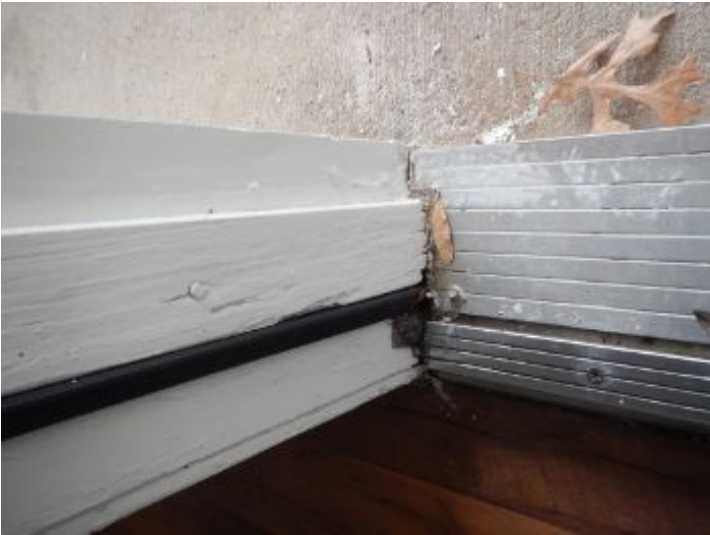
Wood rot at base of door jamb

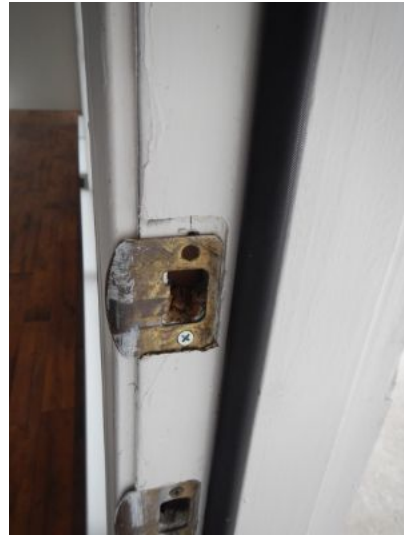
Hardware on back door to pool is missing screws

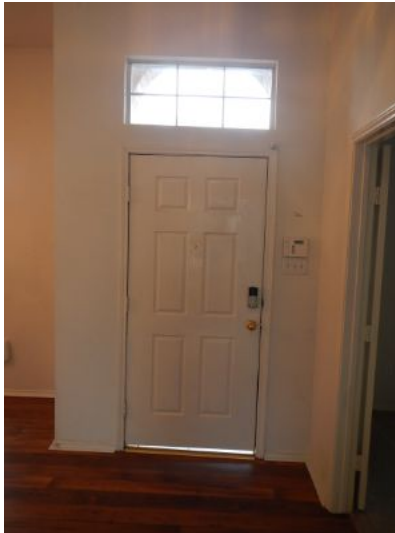
Missing threshold at base of front door

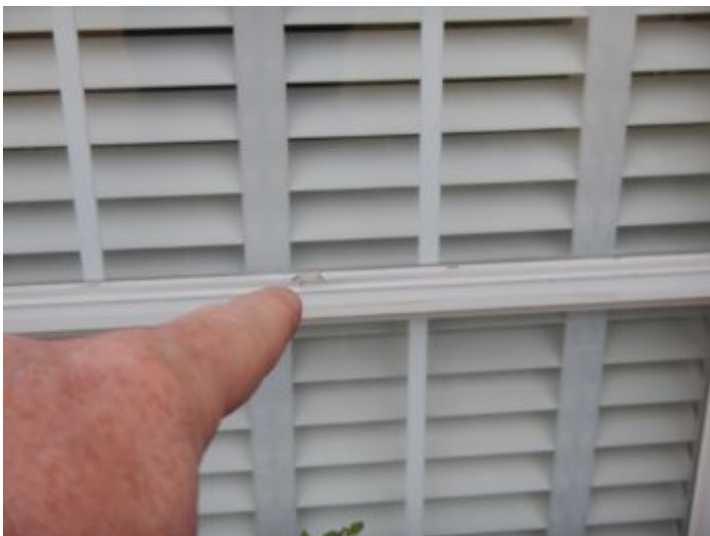
Several windows have damaged trim strips

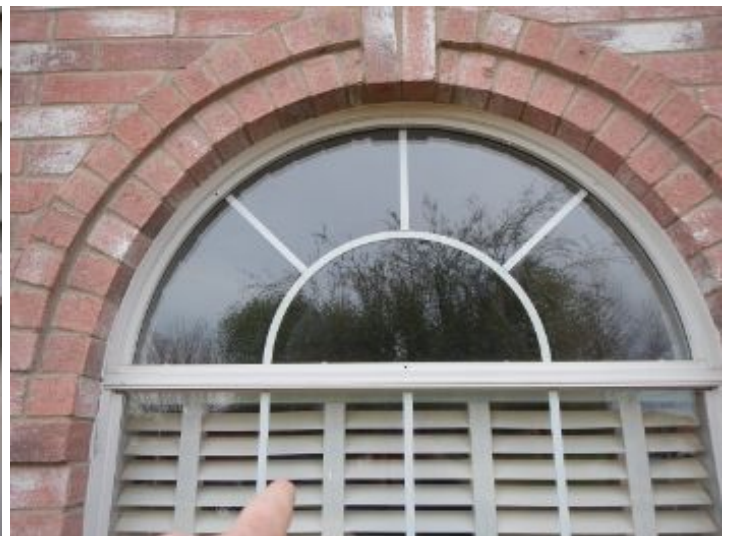
Formal room window is fogged and needs repair

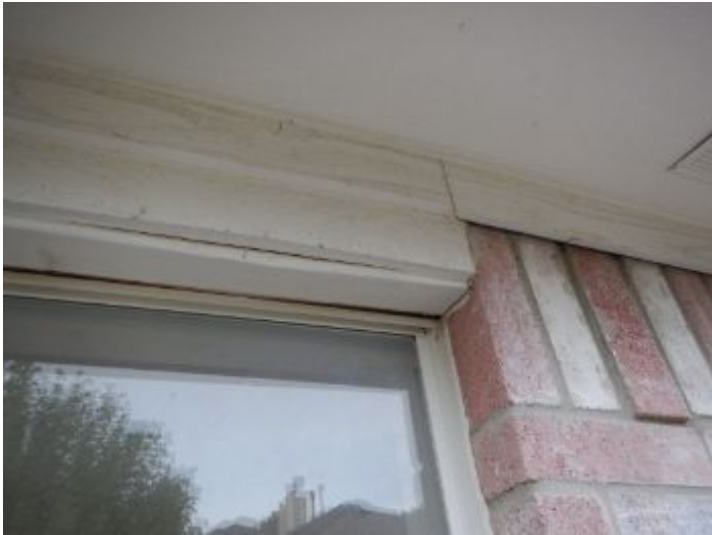
Several windows need to be sealed around

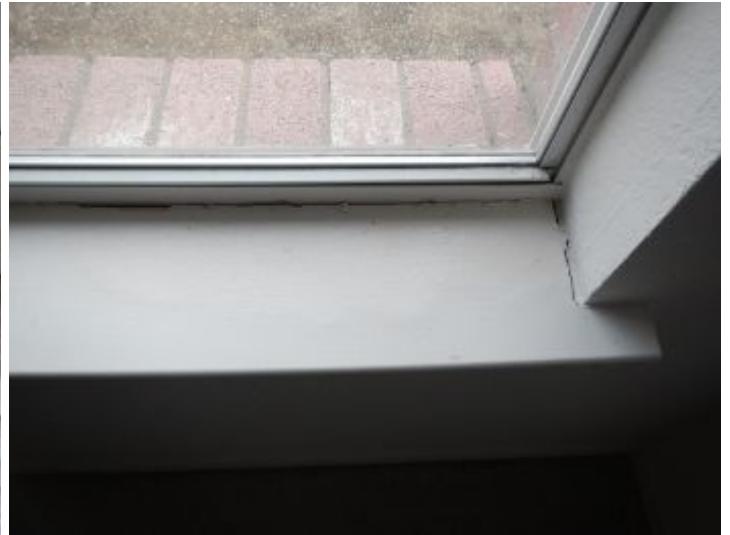
Several window sills are swollen and need repair

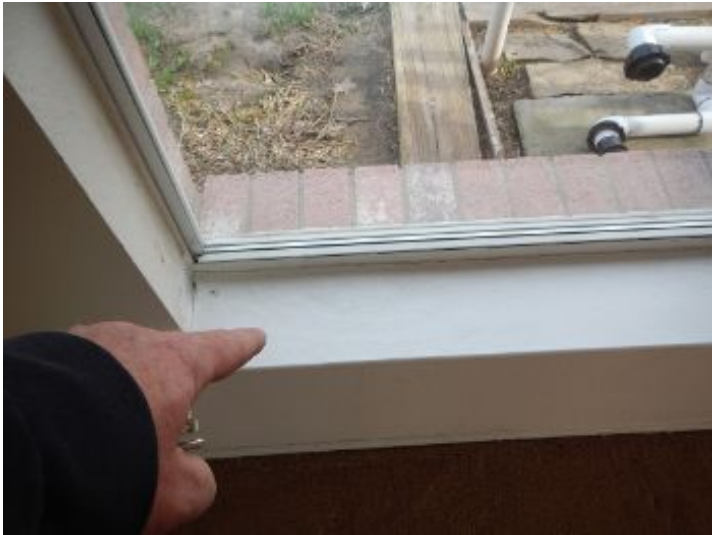
Master window is swollen and needs repair

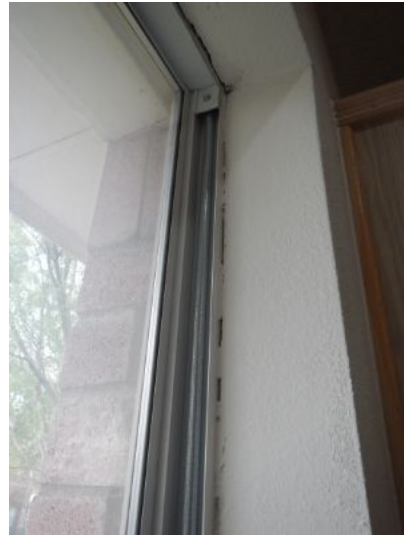
Seal around several interior windows

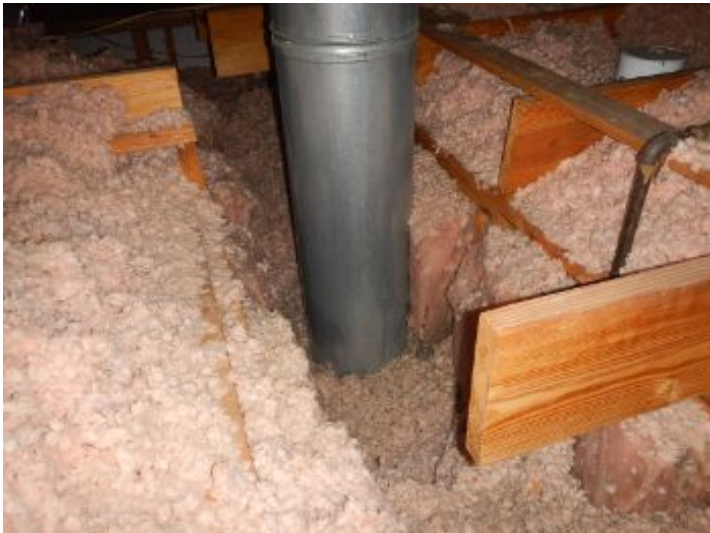
Chimney flue should be free from insulation in attic space

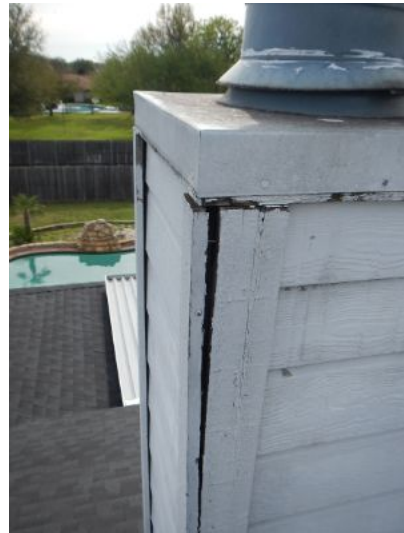
Trim boards on chimney need to be repaired or replaced

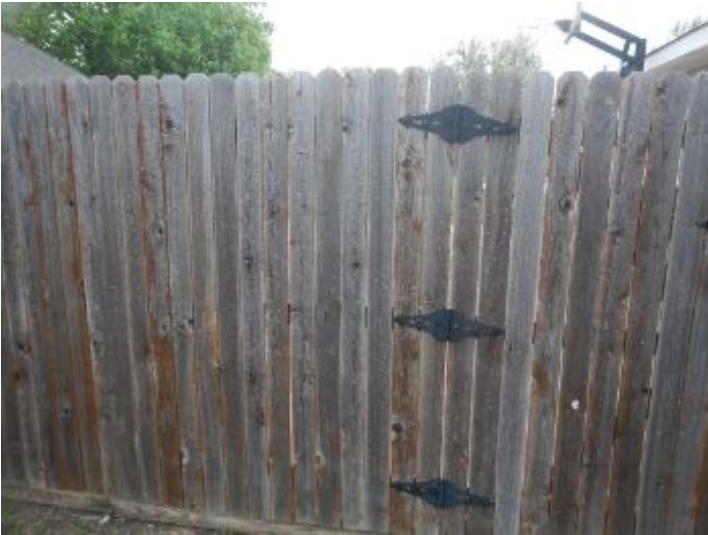
Cosmetic hail damage to fence in several areas

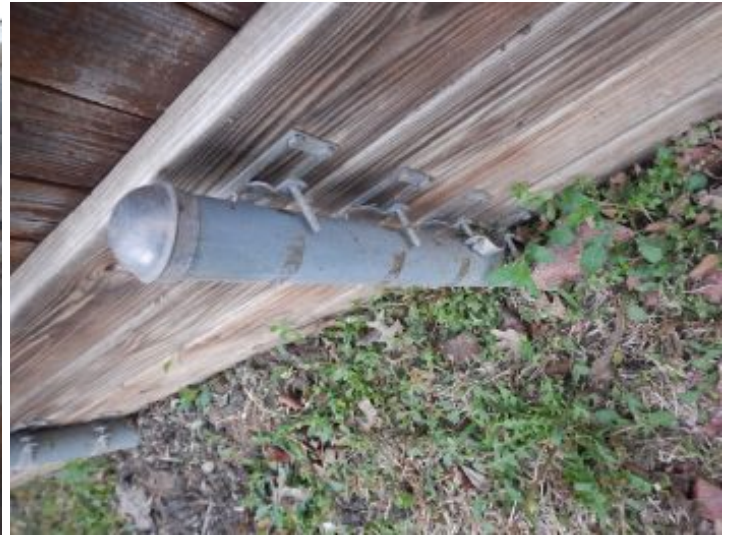
- **The fence and retaining wall should be evaluated by a professional for repairs to fence and wall. The retaining wall has several issues of post that need repair and hardware missing**

Retaining wall for fence is missing alot of hardware

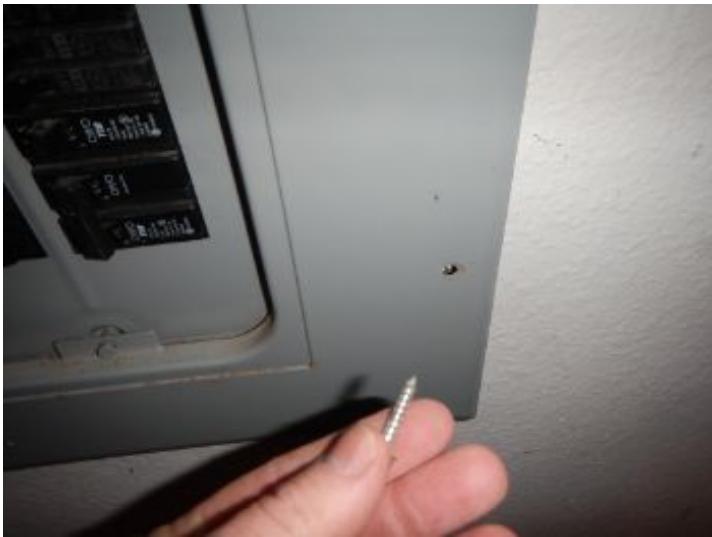
Pointed screws for service panel are not recommended

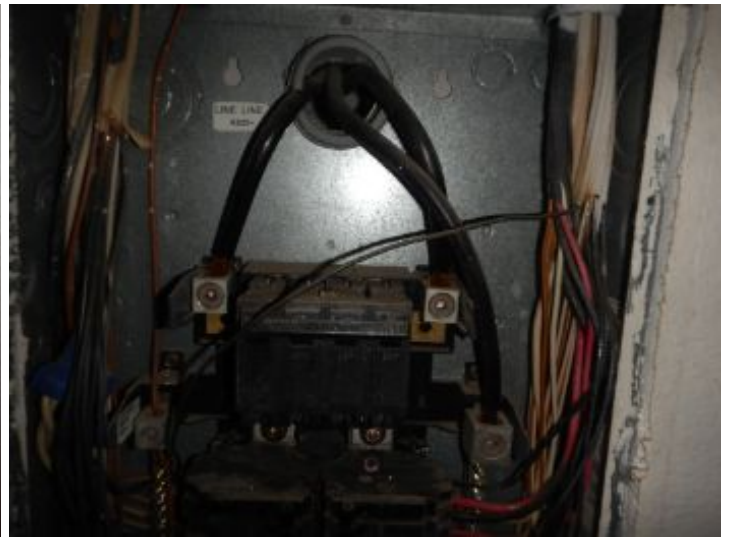
Hot wire across panel is not recommended

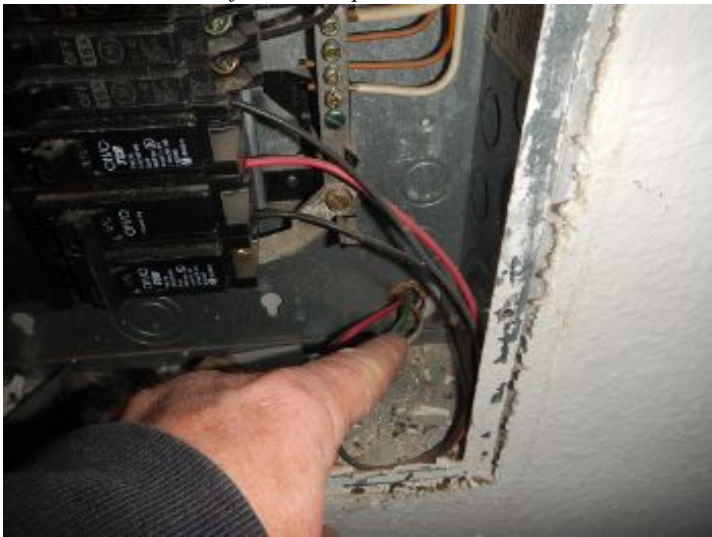
Grommet missing on service panel for exterior

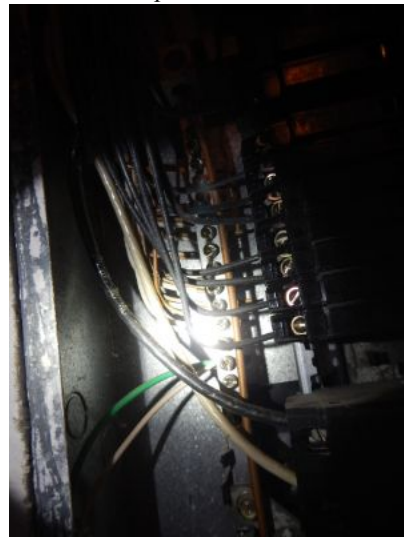
Ground and neutral wires together on bus bar are not recommended

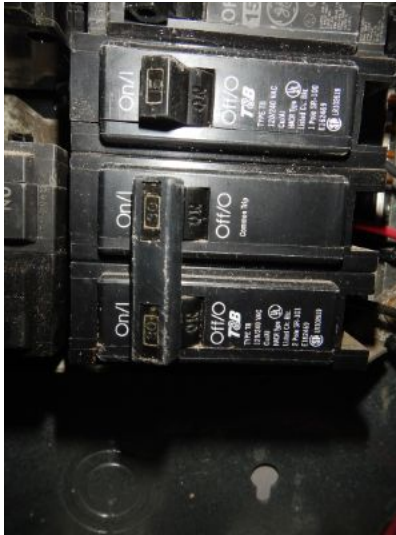
Breakers are not GE brand in panel

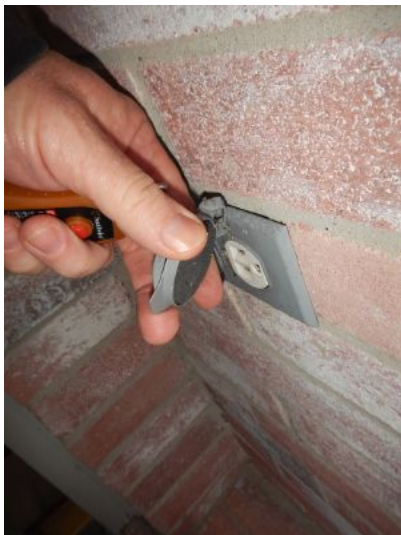
Damaged outdoor cover on front porch

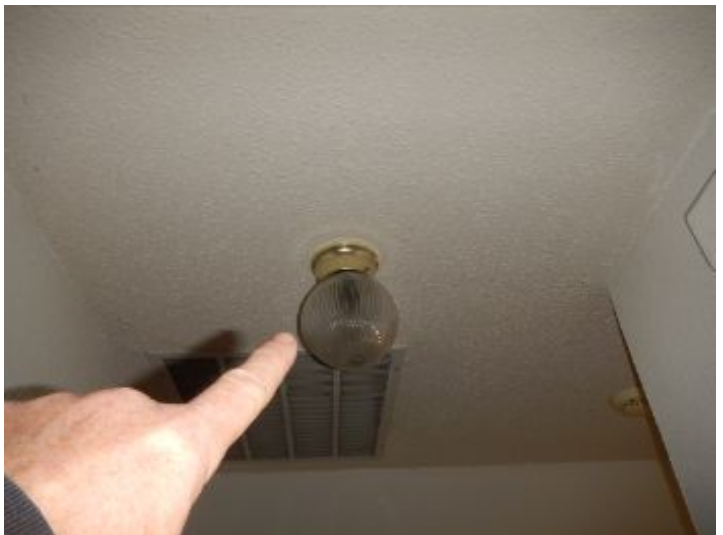
Hall light fixture was not working at time of inspection

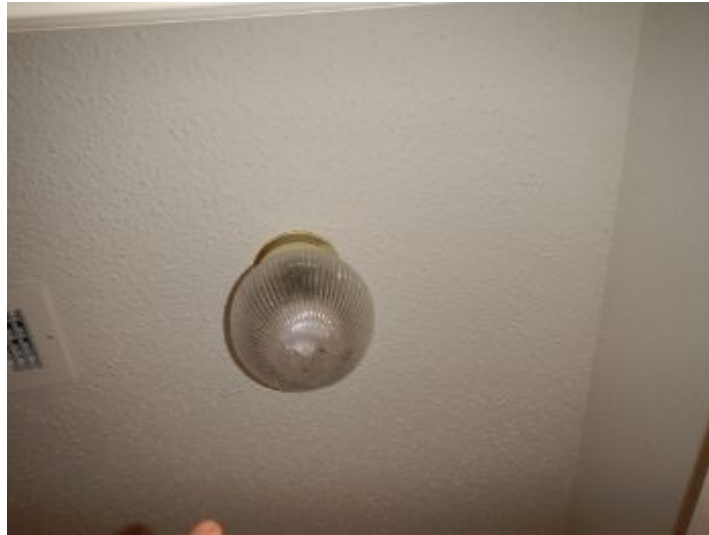
Hall bath light not working

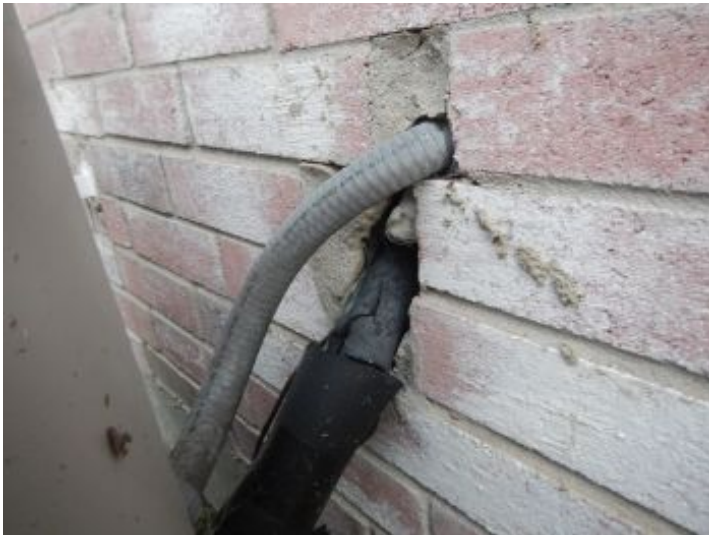
Outdoor lines need to be covered and sealed at home

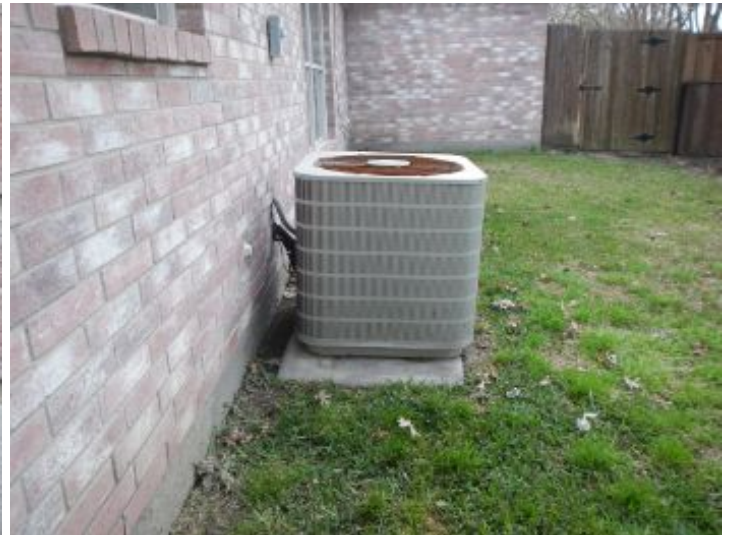
Unit is out of level at time of inspection

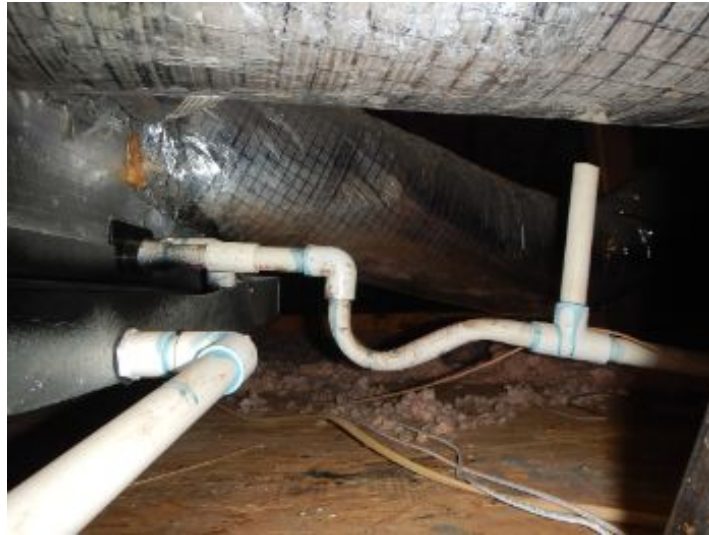
Condensation lines at unit need to be insulated

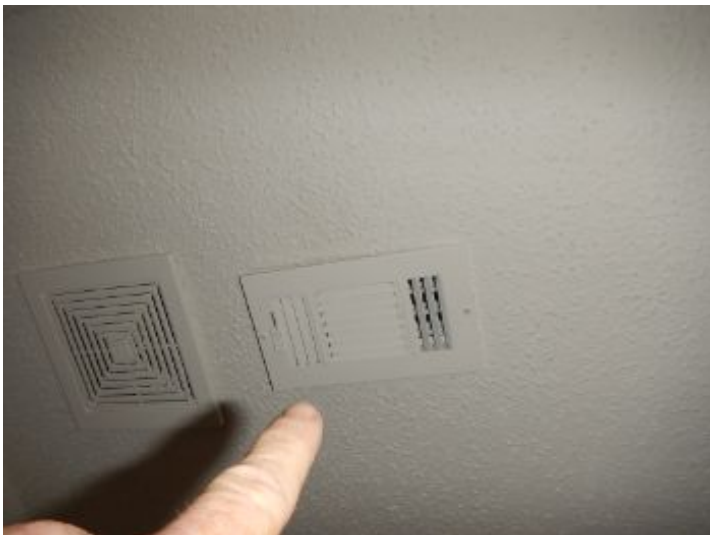
Hall bath supply register is loose at ceiling

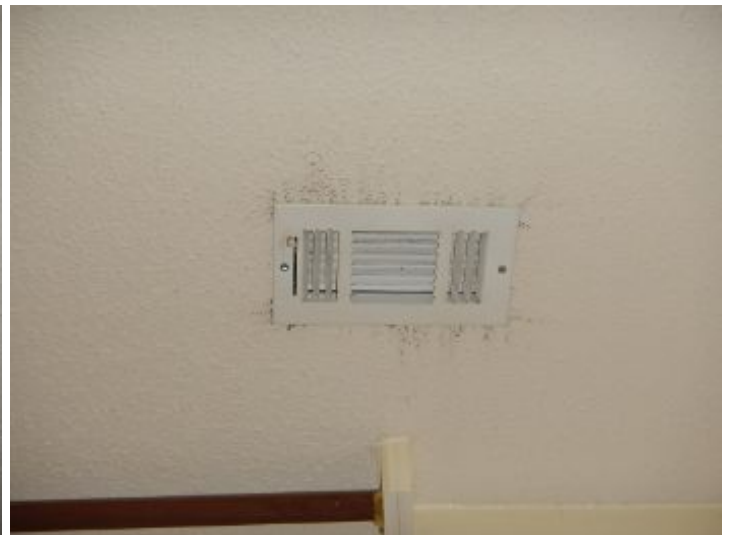
Several dirty supply vents should be evaluated

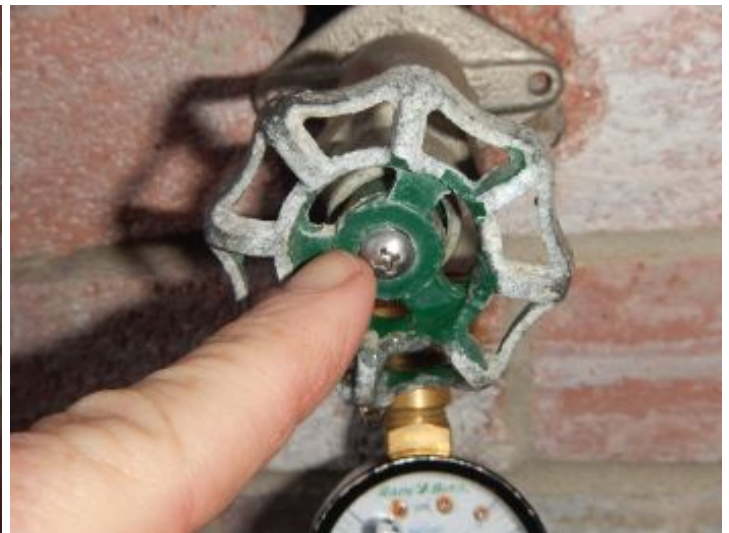
Front faucet leaks when under pressure

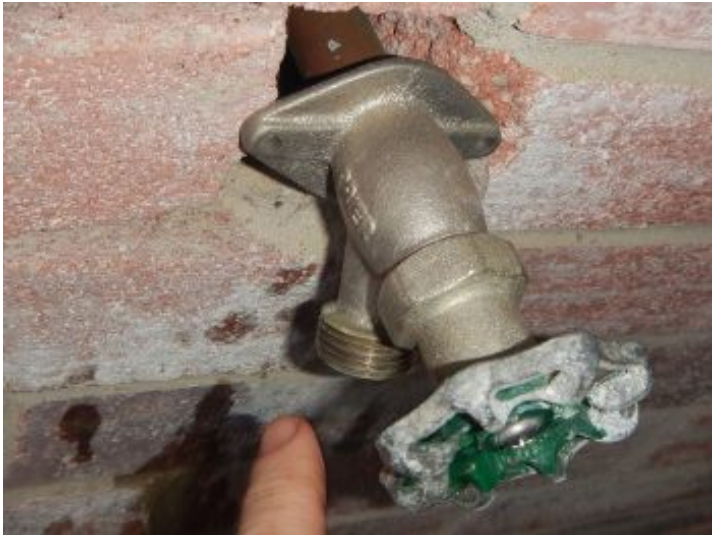
Missing frost preventer should be installed

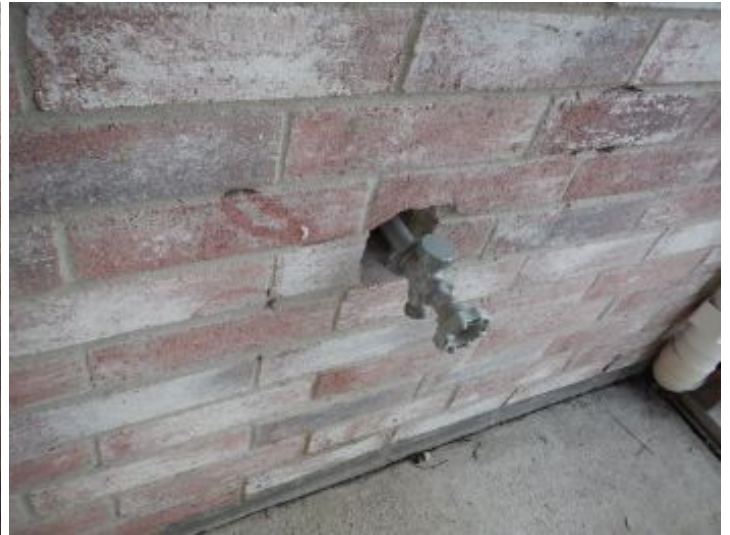
Back porch faucet needs to be properly sealed

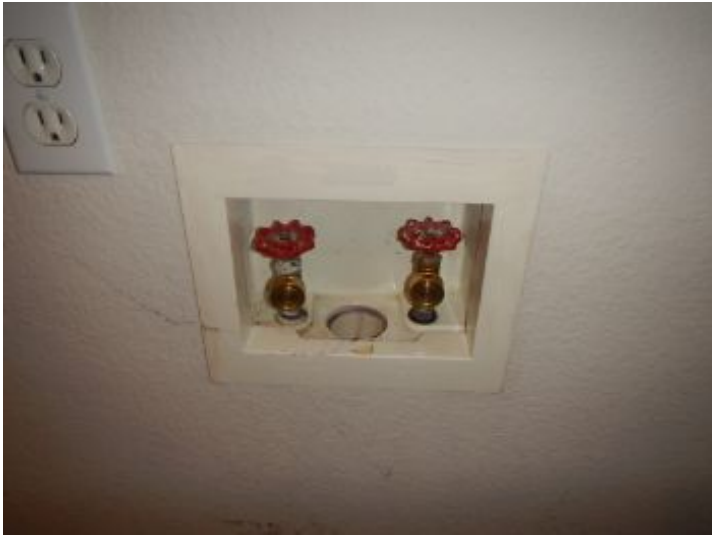
Both hot and cold faucets are leaking

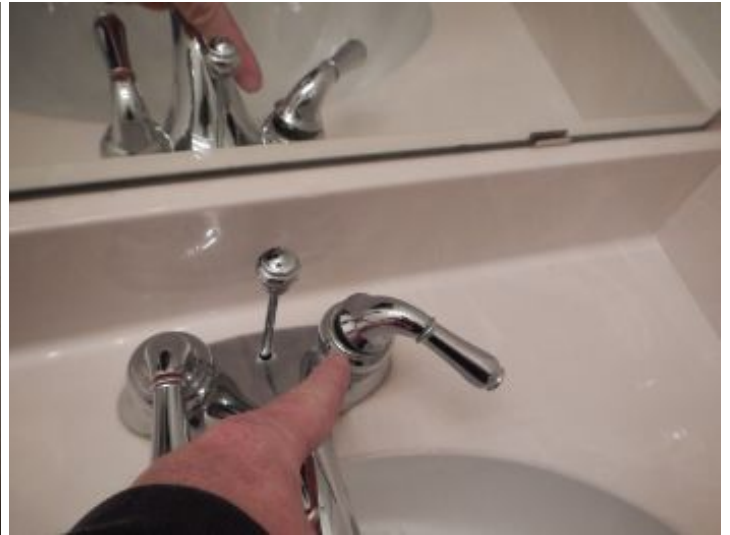
Right vanity in hall bath is loose and needs repair

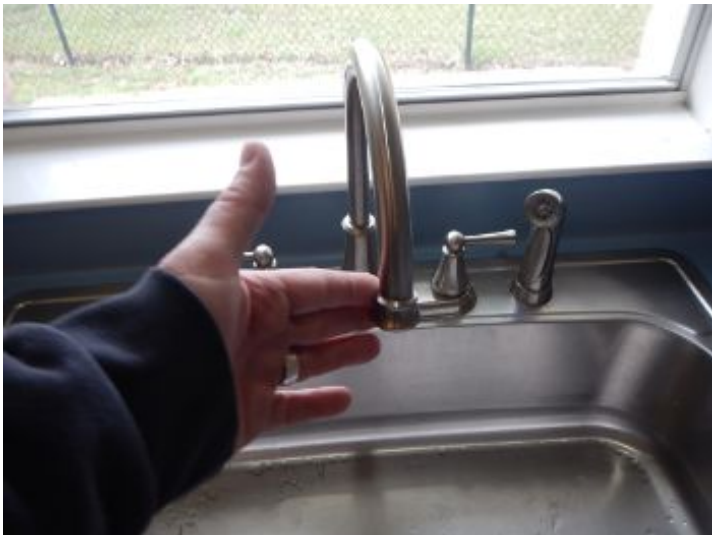
Kitchen sink is dripping and needs to be repaired

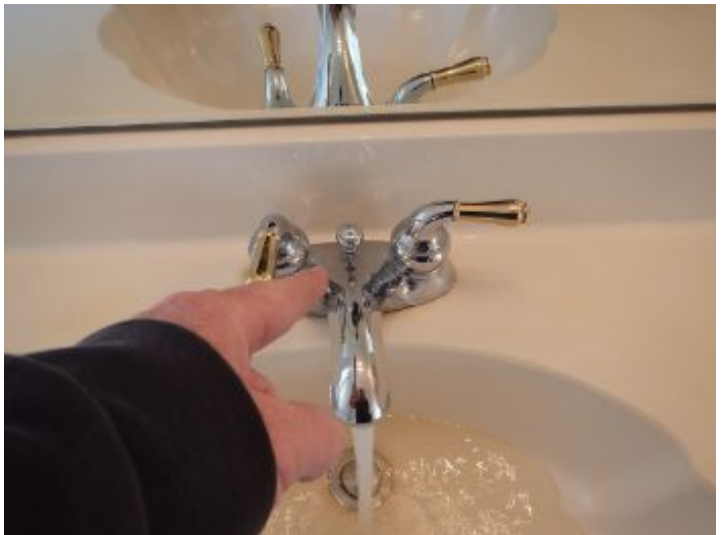
Left master vanity drain stopper needs to be adjusted

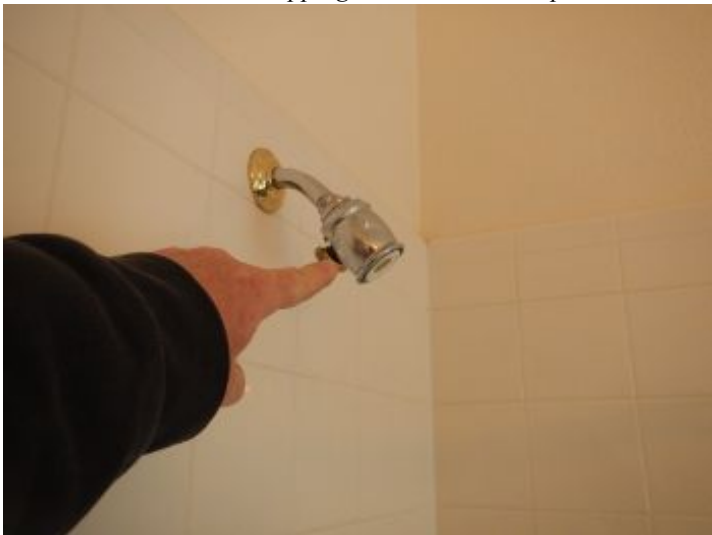
Master shower is dripping at time of inspection

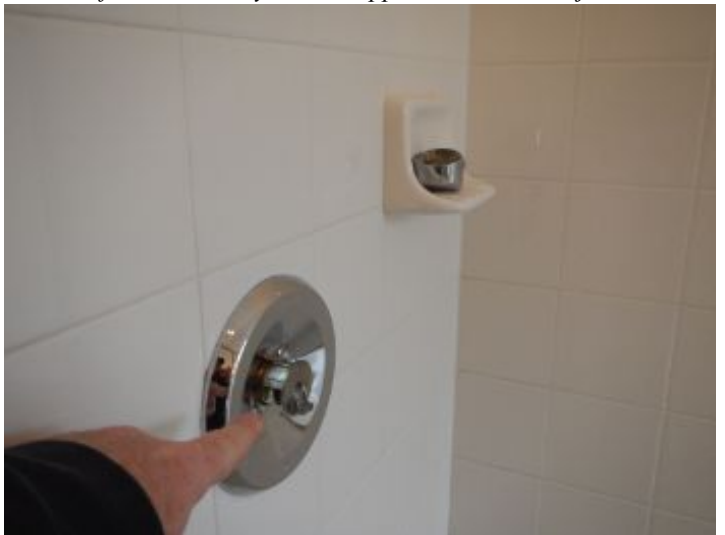
Master shower handle was removed prior to inspection. This should be repaired

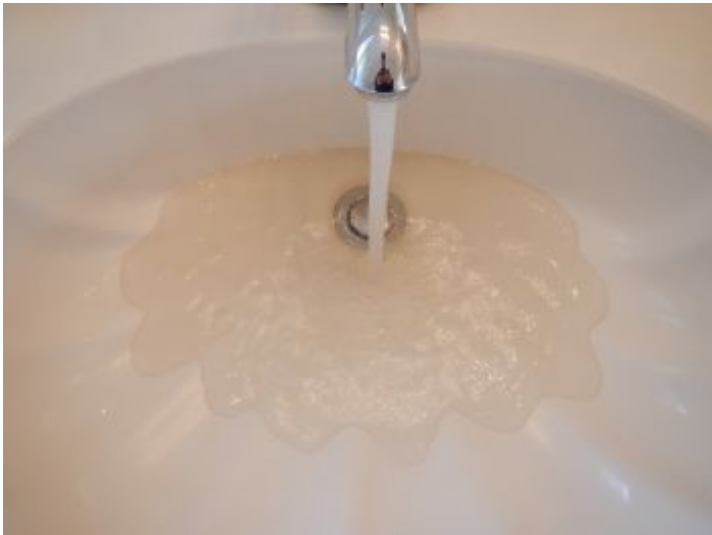
Rust colored water should be evaluated by a licensed plumber

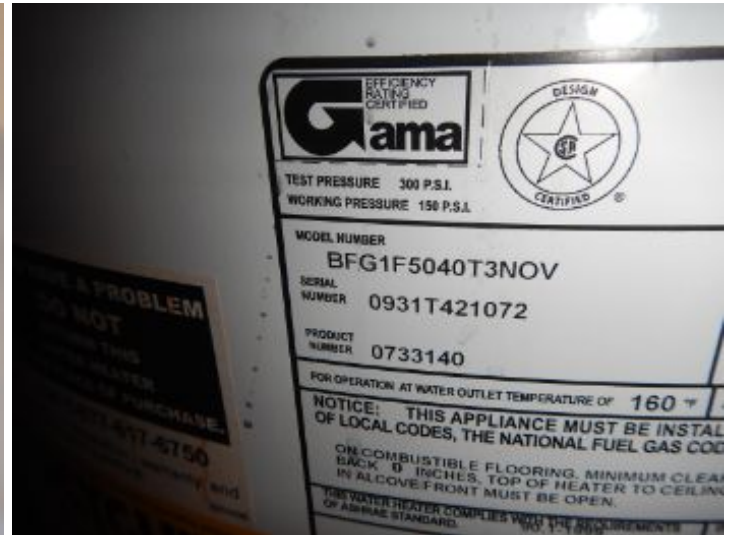
Unit appears to be a 2009 and should be evaluated

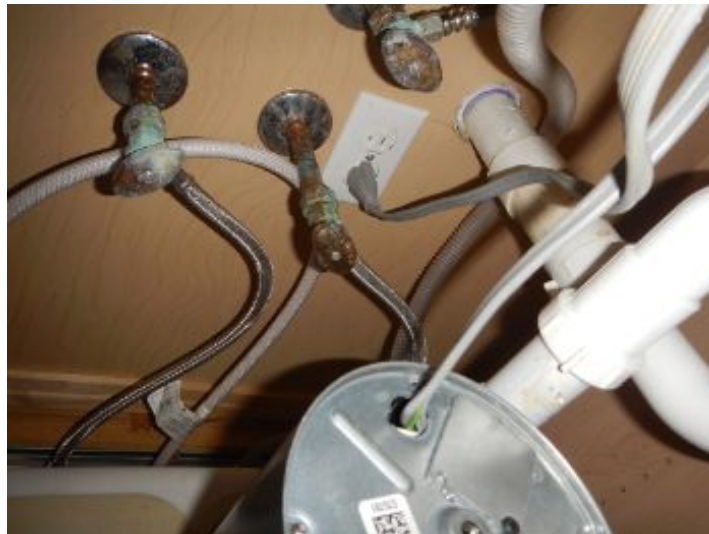
- Disposal was inoperable at time of inspection. The unit appeared to be locked up and need to be repaired. The unit also was missing a grommet to hold cord in place where it meets the unit.

Unit was locked up at time of inspection

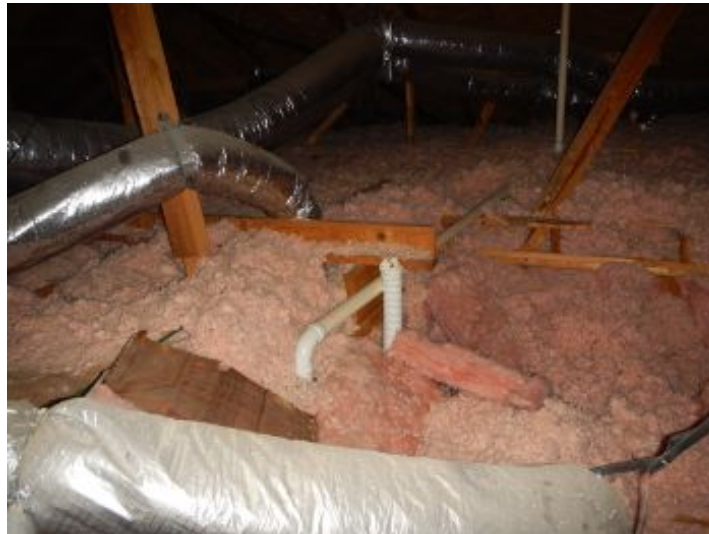
- **The vent fan terminated in the attic space and should be vented to the exterior as per current building standards**

Bathroom exhaust dump into attic space

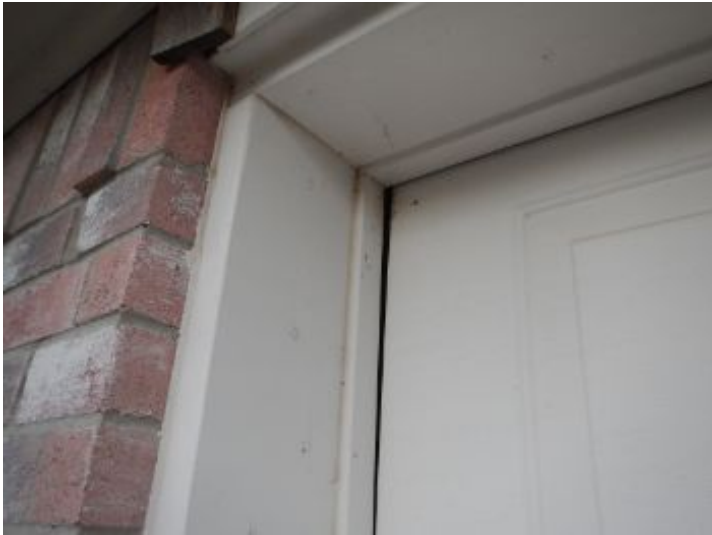
Garage door appears out of align at time of inspection

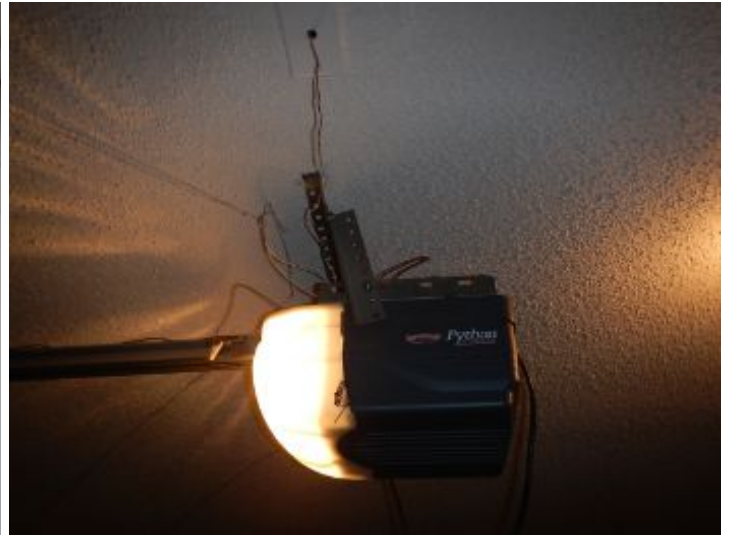
Garage door opener was not working

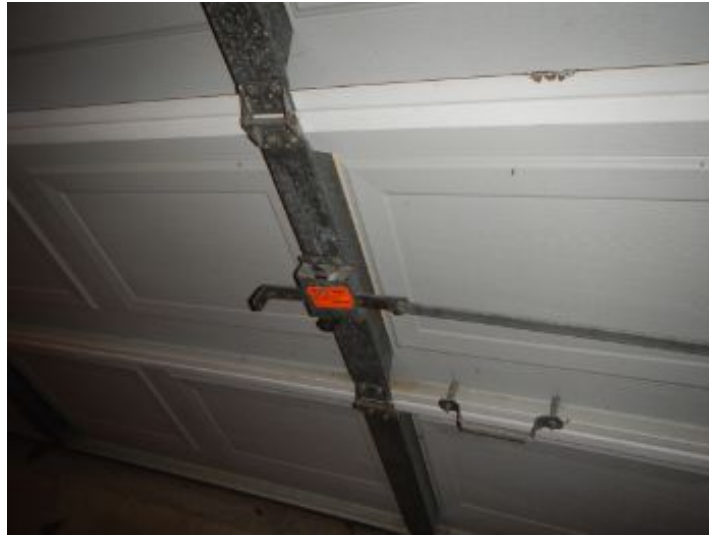
Manual locking devices should be terminated with an automatic opener

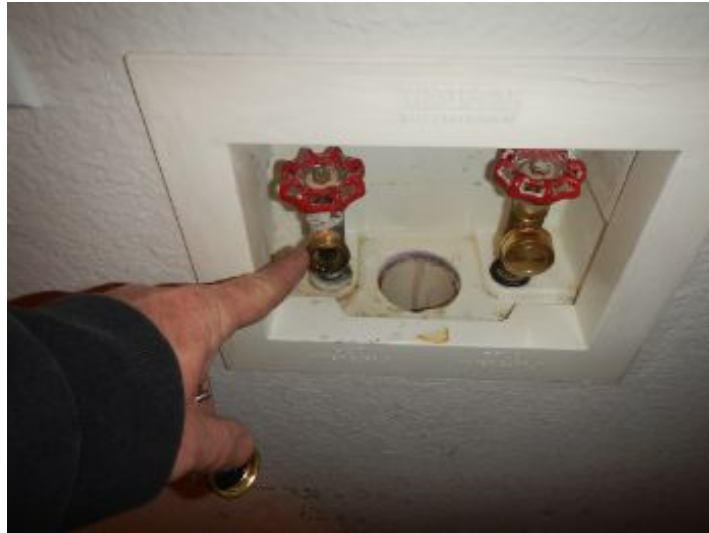
- The water supply valves to the washer were observed to be either leaking, damaged and/or corroded

Hot and cold water valves appear to both be leaking
