DFW Premier Home Inspections

Property Inspection Report

1234 Home Inspection way
Inspection prepared for: Sample Report
Real Estate Agent: Support - Home Inspector Pro

Date of Inspection: 5/20/2019 Time: 08:00
Age of Home: 1980 Size: 2265
Weather: overcast 45 degrees

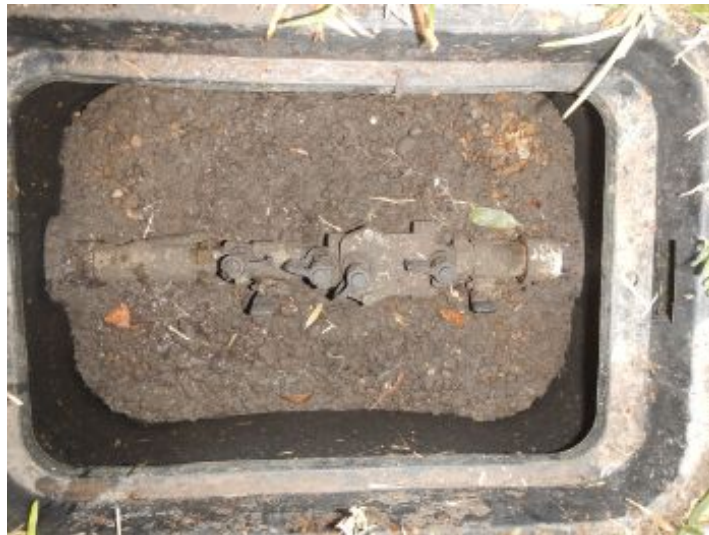
- Main valve to irrigation was shut off at time of inspection. This was not tested by home inspector. I recommend that the system be evaluated by a professional for proper operation

Irrigation double check was shut off at time of inspection
