DFW Premier Home Inspections

Property Inspection Report

1234 Home Inspection way
Inspection prepared for: Sample Report
Real Estate Agent: Support - Home Inspector Pro

Date of Inspection: 5/20/2019 Time: 08:00
Age of Home: 1980 Size: 2265
Weather: overcast 45 degrees

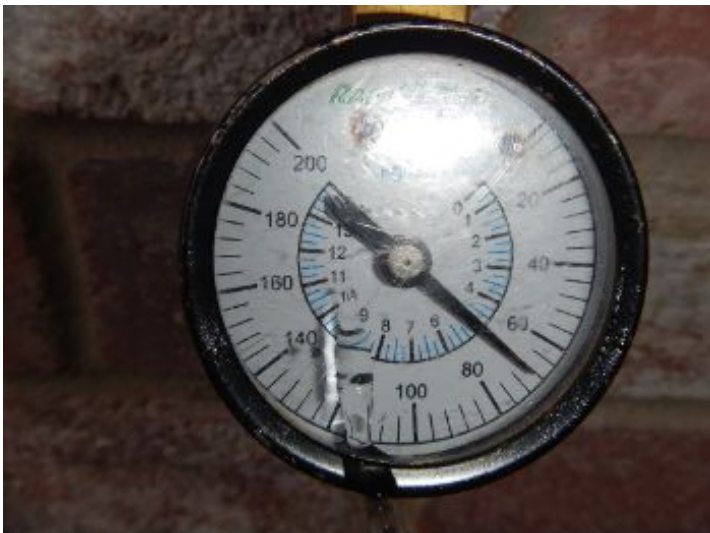
- The anti static water pressure was observed at 70 psi
- The exterior hose bib {faucet} was observed to have a drip at front faucet when under pressure, missing an anti freeze device and the area around fixture needs to be properly sealed. The hose bib on back of home also needs to be properly sealed around
- Hot and cold lines for washing machine are both leaking and need to be repaired
- The water supply handle on right side of hall bath is compromised and needs to be repaired. It was loose and came loose when operated
- Kitchen sink has a dripping faucet that needs repair
- Left master vanity is leaking when operated. This should be repaired by a licensed plumber
- Master shower was dripping at time of inspection. The handle had removed prior to inspection. This should be repaired by a licensed plumber

70 psi static water pressure
